Manhole Inspection Summary

Manhole # S33AA1001MH

Insp Date: **3/5/07 3:56 PM**

Location Address: **3339 34TH ST**

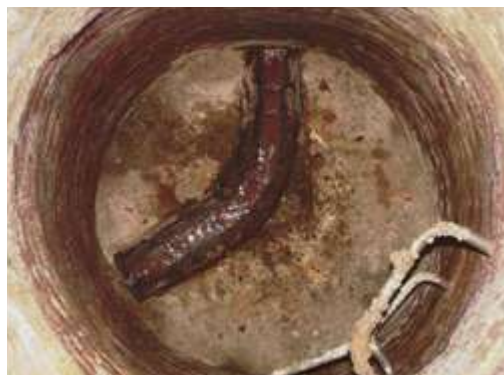
Top View

Bench debris.

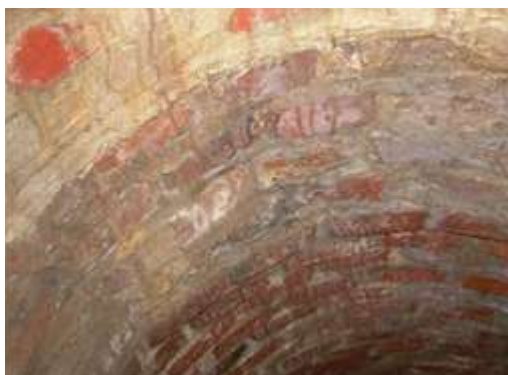
Defect

Infiltration: ☐ None ☒ **Joint** ☐ Cracks ☒ **Mortar** ☐ Roots ☐ Wall

Infiltration: ☐ None ☐ Joint ☐ Cracks ☐ Mortar ☐ Roots ☒ **Wall**

Adjustment, Corbel, and Barrel infiltration.

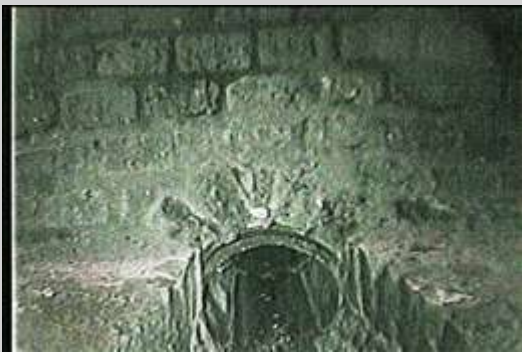
Pipe Out @ 12 O'Clock

Comments **The O12 pipe seal is not flush to the pipe.**

Infiltration: **Evidence** Pipe Seal Cond: **Unknown**

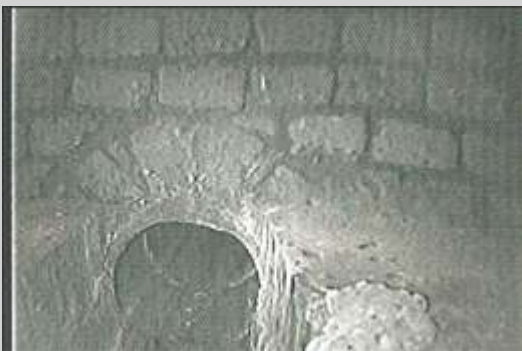
Pipe In @ 8 O'Clock

Infiltration: **Evidence** Pipe Seal Cond: **Unknown**
